# **Wilson Road Corridor Flooding:** **An Overview of the December 2020 Storm** **Event, Drainage History, and Recommended** **Future Flood Mitigation**

Todd Boris, PE  
53 Wilson Road, Gustavus, Alaska  
December 14, 2020

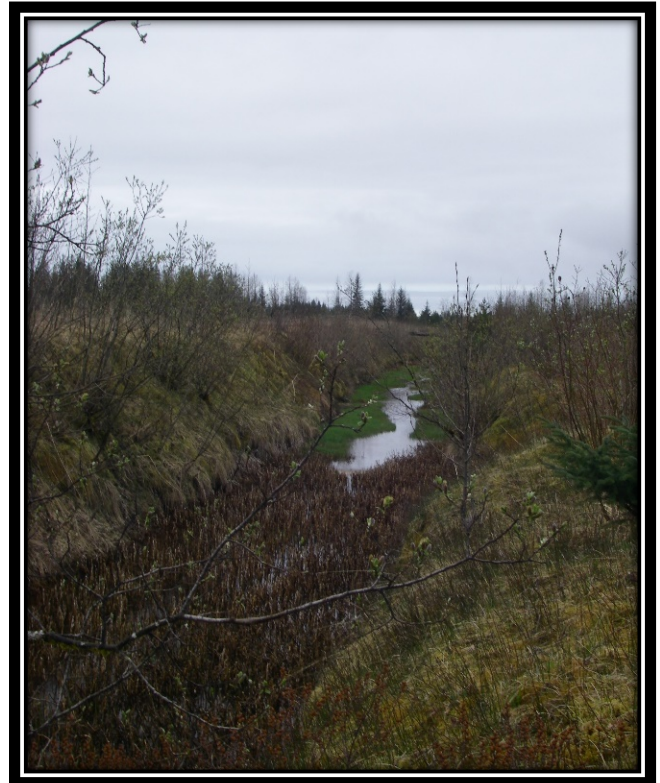
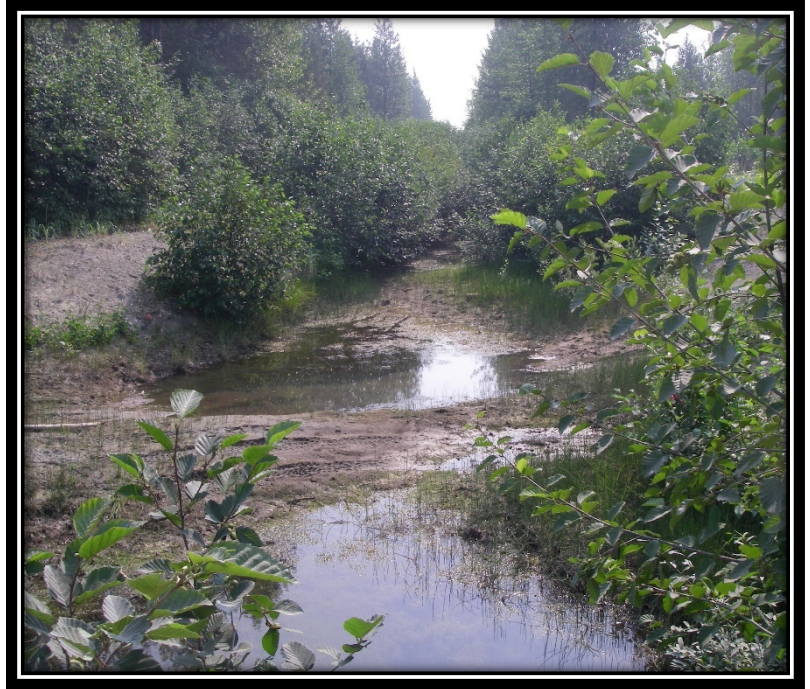
The airport's east-side diversion has filled in through sedimentation since it was initially excavated. Alder and cottonwood trees now thrive on the diversion's banks. Willow bushes, sediment, fallen logs, and aquatic vegetation choke off the diversion's capacity and strangle the diversion's effectiveness to control water

flowing through the facility. A few photos of the airport's east-side diversion are presented as exhibits to the drainage facility's typical condition.

Witnesses reported the diversion intercepts, captures, and re-directs little, if any, of the runoff and overflow coming from the upland drainage. One witness reported a culvert crossing the diversion was partially full while Wilson Road flooded in 2018, highlighting the ineffectiveness of the diversion's current and poor condition. Stormwater bypassed the diversion and flowed uncontrolled; flooding the Wilson Road corridor.

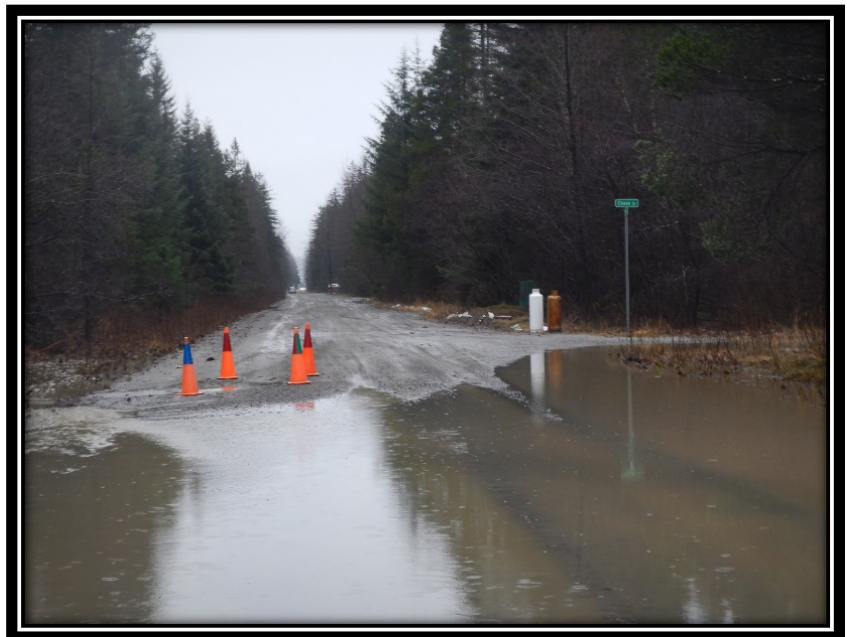
The ditches seem to improve drainage along Wilson Road during light to moderate surface runoff, but become overwhelmed during flooding events due to its small capacity. However, the benefit of the east-side ditch to help recede floodwater is shown in the photo taken at the Wilson Road/Chase Drive intersection. Unfortunately, the west-side ditch is not as effective (also shown in the photo). The culvert under Wilson Road near Chase Drive had either been

crushed, severed, or both due to its shallow burial. In the December 2020 storm event, hydrostatic pressure from the west-side ditch liquified Wilson Road’s surface course material near the culvert’s severed outlet, blowing out a hole in Wilson Road as a result. A larger deeper buried culvert and clearing obstructions (mostly roadway surface coarse material) from both ditches would likely mitigate some flood risk and damage by draining the roadway and adjacent properties faster.

If interested, the City of Gustavus may be able to leverage State of Alaska emergency funds to repair road damage caused by the December 2020 storm event including replacing the failed culvert that welled up through Wilson Road and excavating flood debris and sedimentation from adjacent ditches.

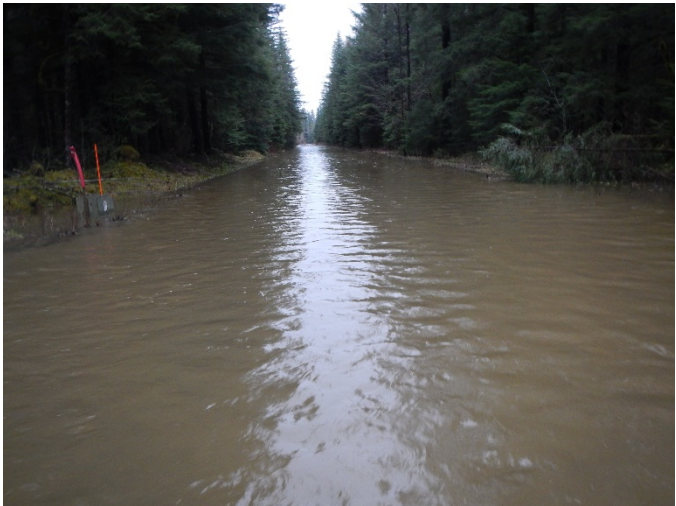
*Figure 1 - Wilson Road Flooding near Hemlock Road (December 2020)*

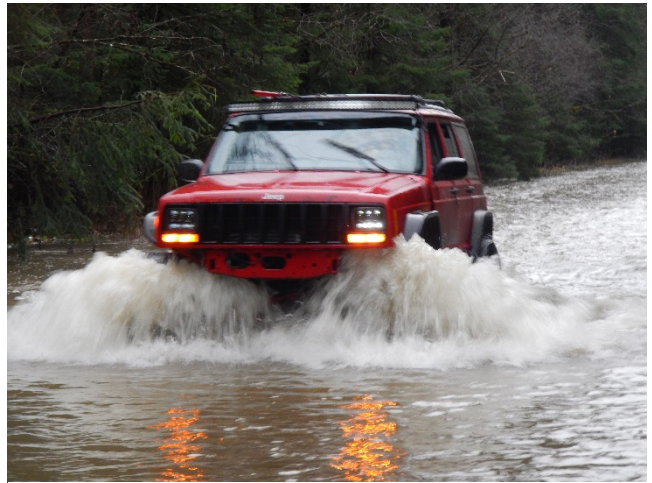
*Figure 2 - Wilson Road Flooding near Jensen Road (December 2020)*

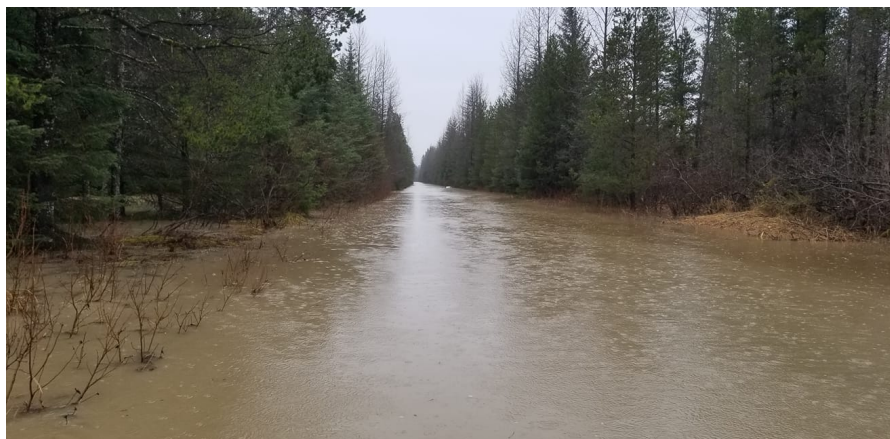
*Figure 3 - Wilson Road Flooding Near Chase Drive (December 2020)*

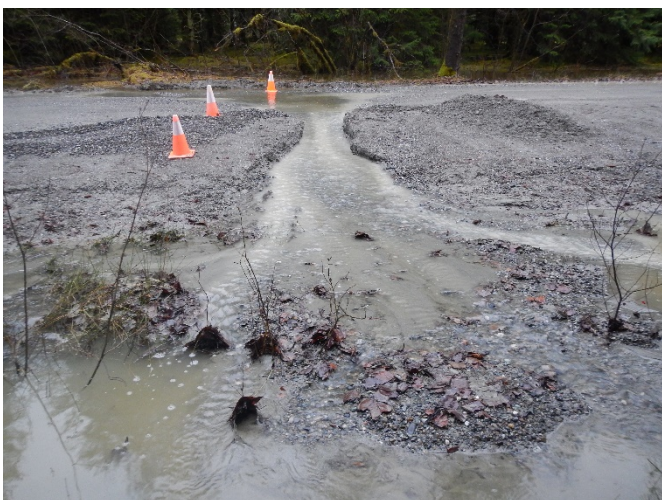
*Figure 4 - Wilson Road Damage Near Dock Ponds Trail (December 2020)*

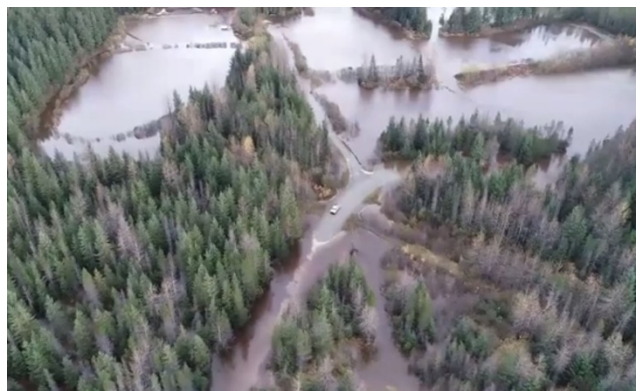
*Figure 5 - Wilson Road Flooding Near Gravel Pits (October 2018)*

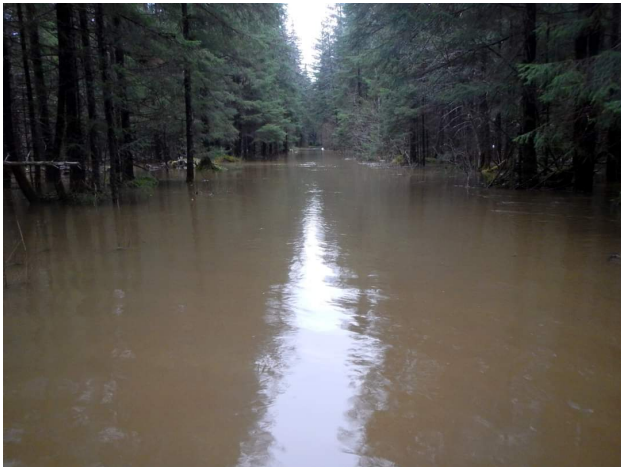
Figure 6 - Flooding on Hemlock Road (December 2020)

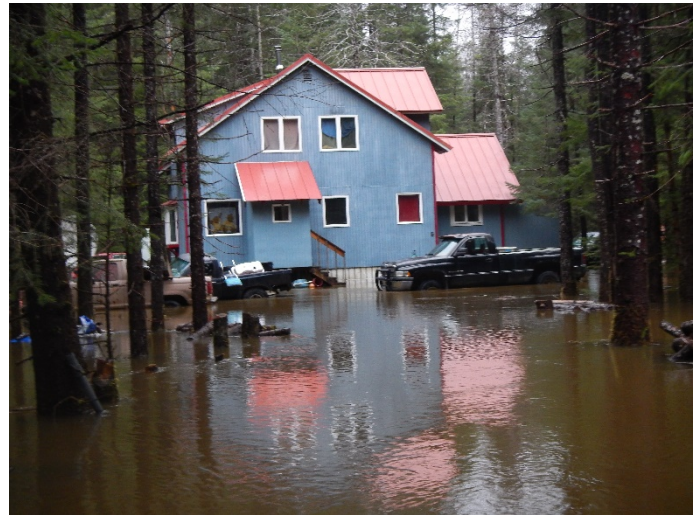
Figure 7 - Flooded Home on Hemlock Road (December 2020)

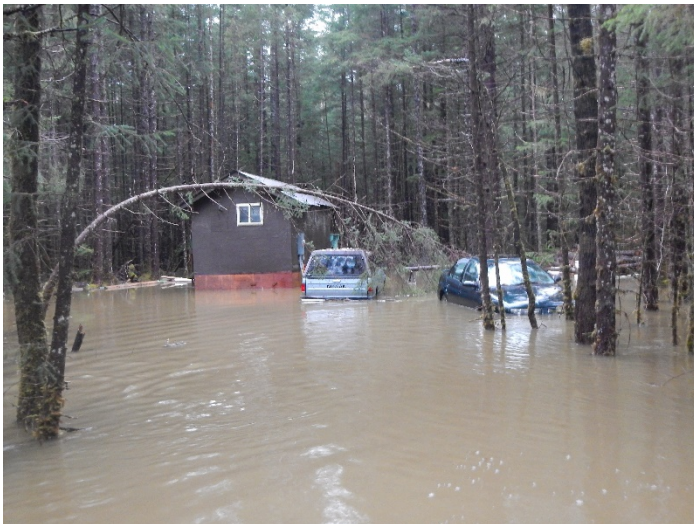
Figure 8 - Flooded Home and Vehicles on Hemlock Road (December 2020)

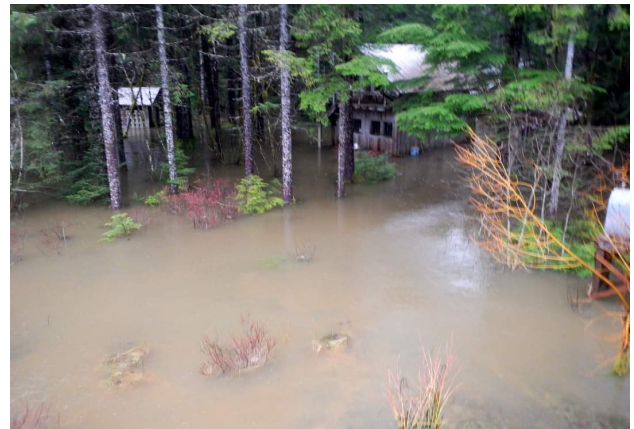
Figure 9 - Flooded Home on Hemlock Road (December 2020)

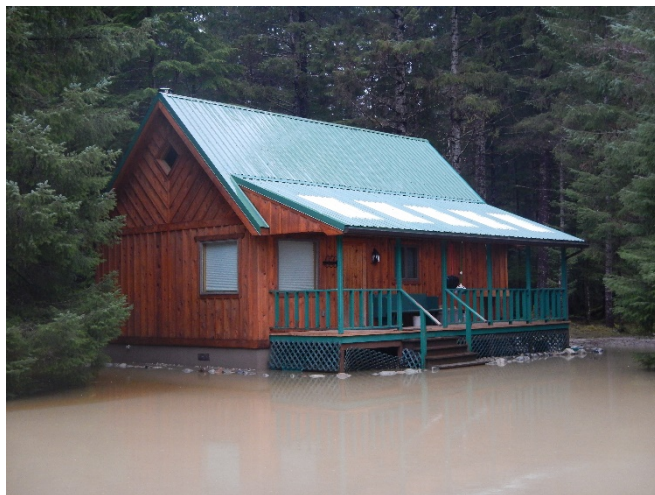
Figure 10 - Flooded Home on Wilson Road (December 2020)

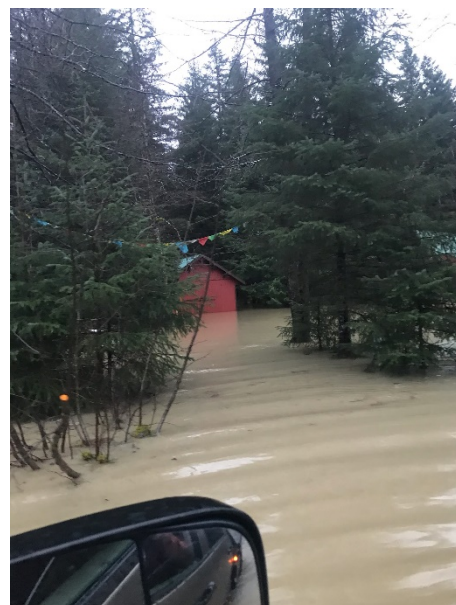
Figure 11 - Chase Driveway Flooding (December 2020)

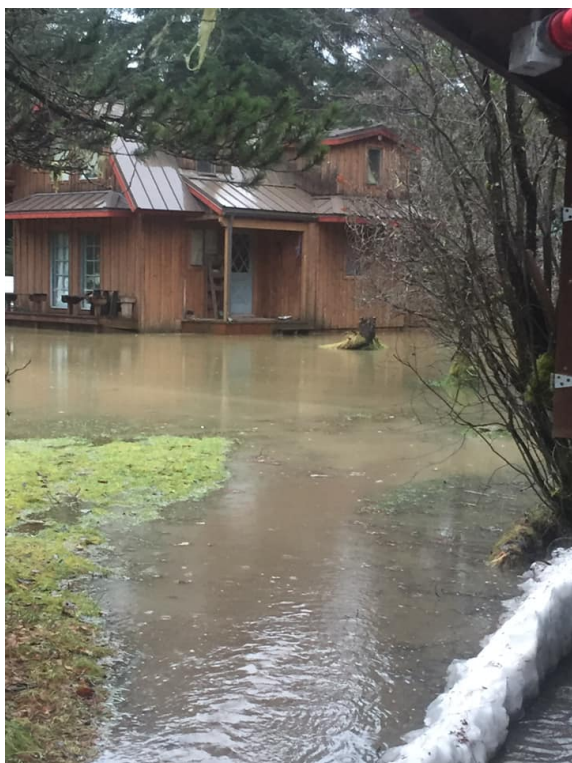
*Figure 12 - Home flooded on Parker Drive*

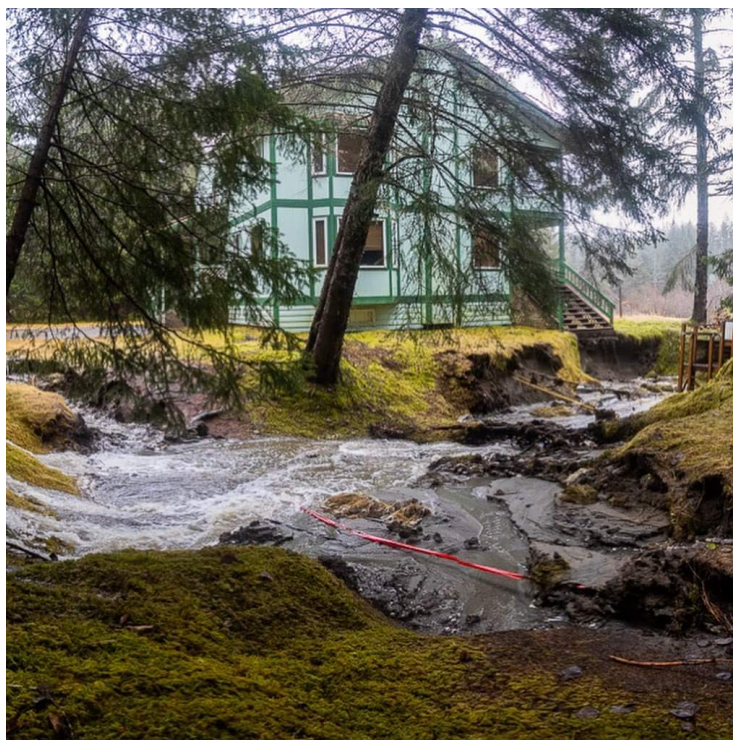
The floodwater eventually found ways to drain. Near the old stream's prior outlet at River Bend Drive, floodwater carved a new eight-foot-deep channel to vent water into the Salmon River. Homes and driveways were also damaged near the end of Parker Drive, which historically served as a pathway to drain upstream meadows (floodplains) into the Salmon River. The remaining water flooded areas south of the airport before draining into Glen's Ditch.

*Figure 13 - Erosion near home on River Bend Drive*

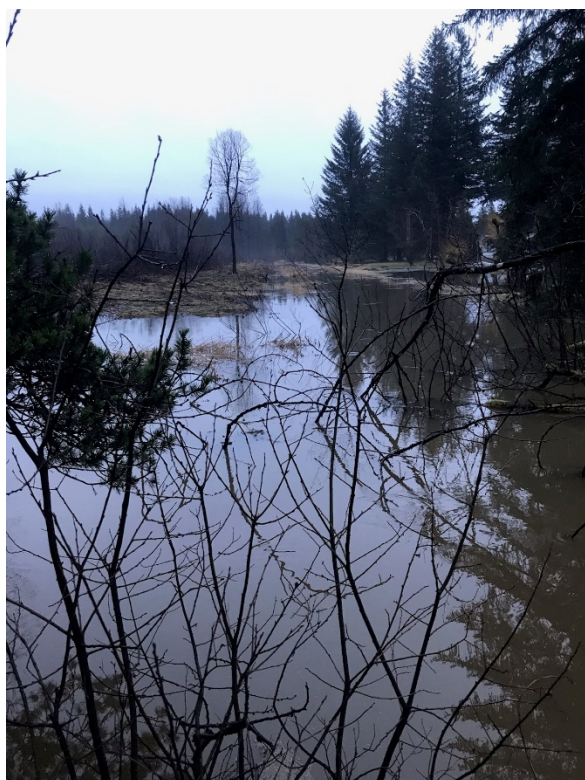
*Figure 14 - Flooded duck ponds near Wilson Road*

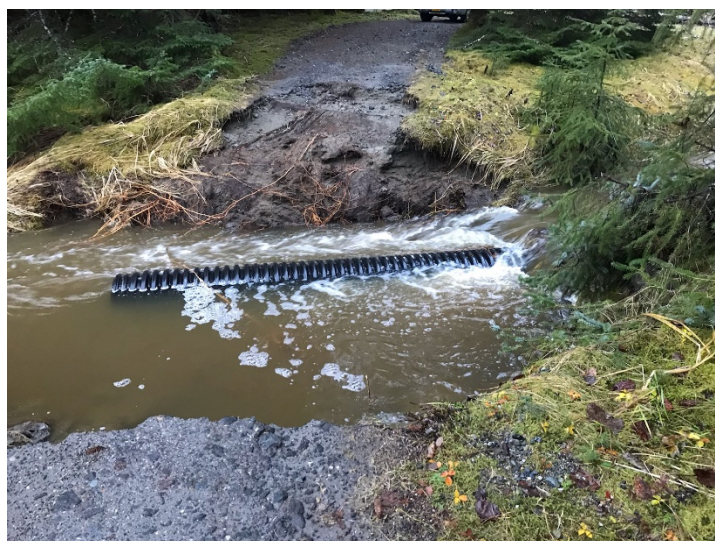
*Figure 15 - Washed out driveway on Parker Drive*
