# **Wilson Road Corridor Flooding:** **An Overview of the December 2020 Storm** **Event, Drainage History, and Recommended** **Future Flood Mitigation**

Todd Boris, PE  
53 Wilson Road, Gustavus, Alaska  
December 14, 2020

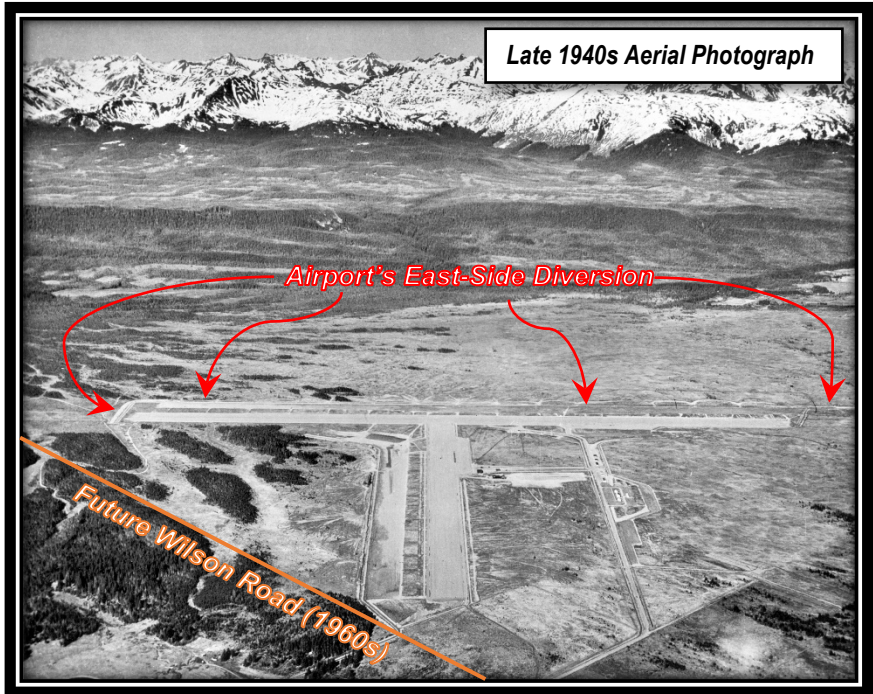
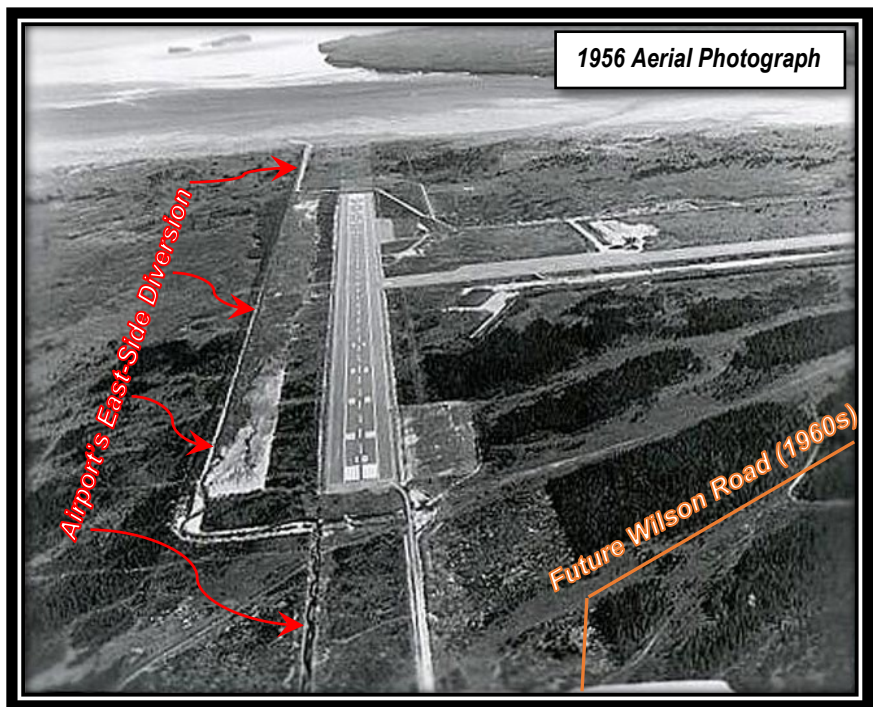
runways and aprons were paved with asphalt concrete. The east-side airport diversion would also be extended beyond the north end of runway 11/29 to the present location of Gustavus' gravel pits, channeling additional surface water to tideland for further flood protection.

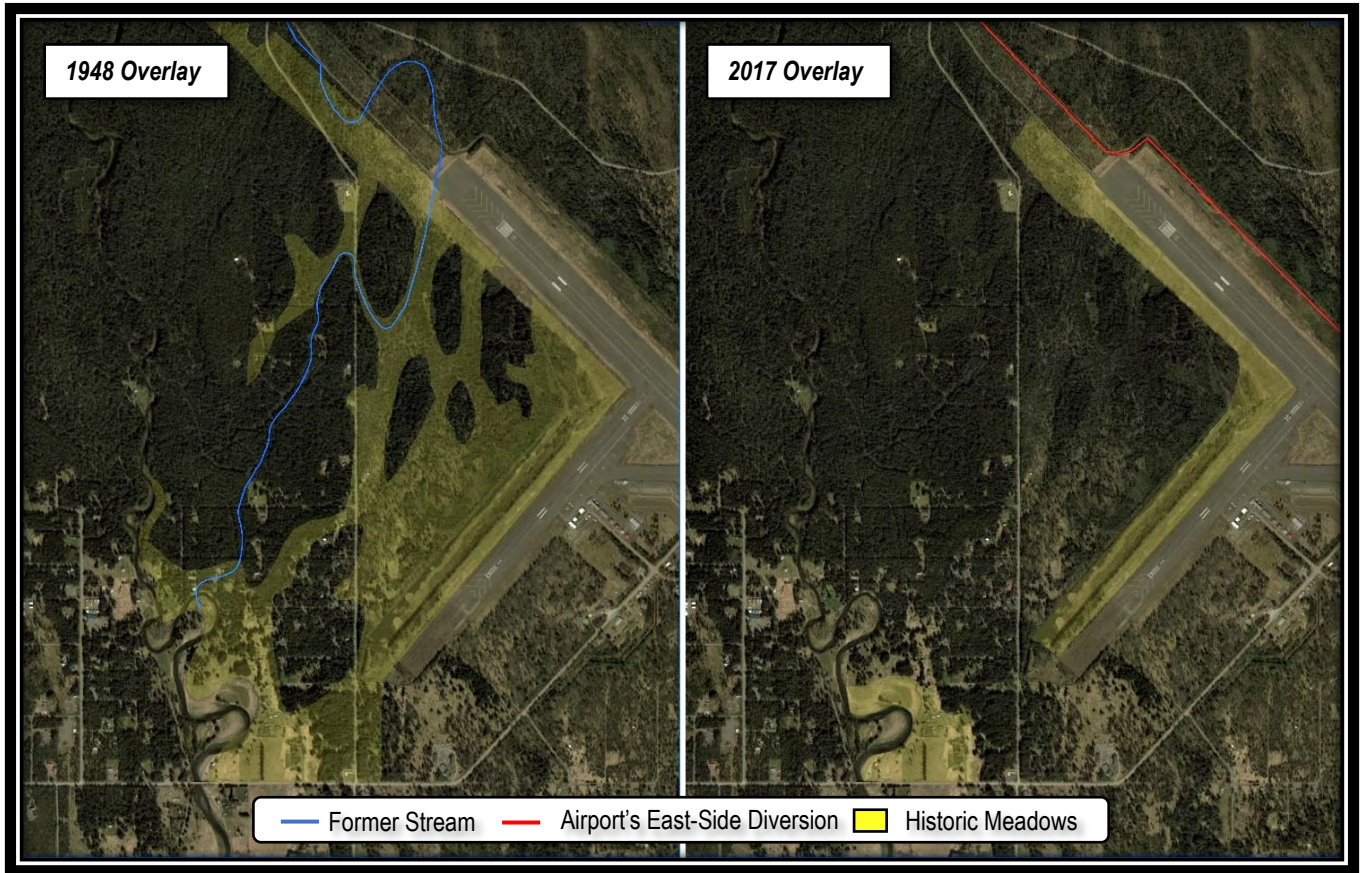
In the altered ecosystem, a thick forest of spruce, pine, and alder grew to fill the drainage within the corridor. Comparing the area's drainage features and vegetation in 1948 to 2017 displays the magnitude to which the diversion altered the area's landscape. Moss, trees, and eighty years of forest debris accumulation make the former stream channel indiscernible from the surrounding landscape. The prolific natural meadows have disappeared from the corridor except for the southernmost corner near the Salmon River.

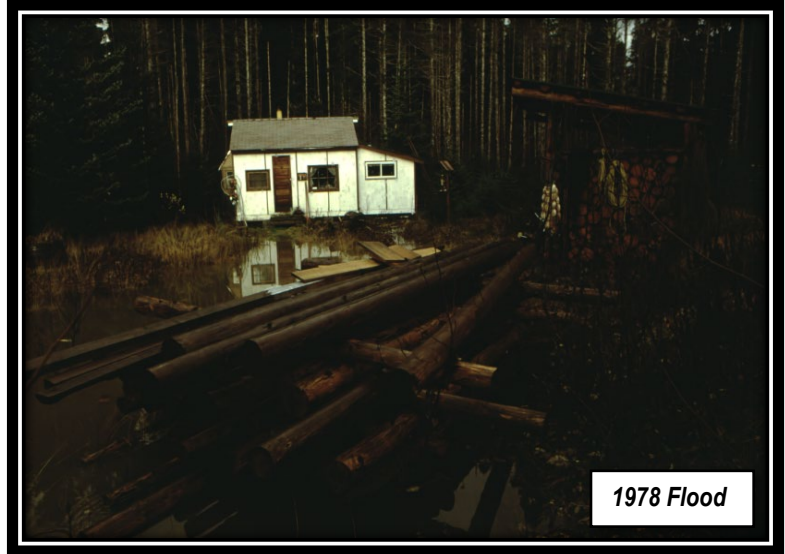
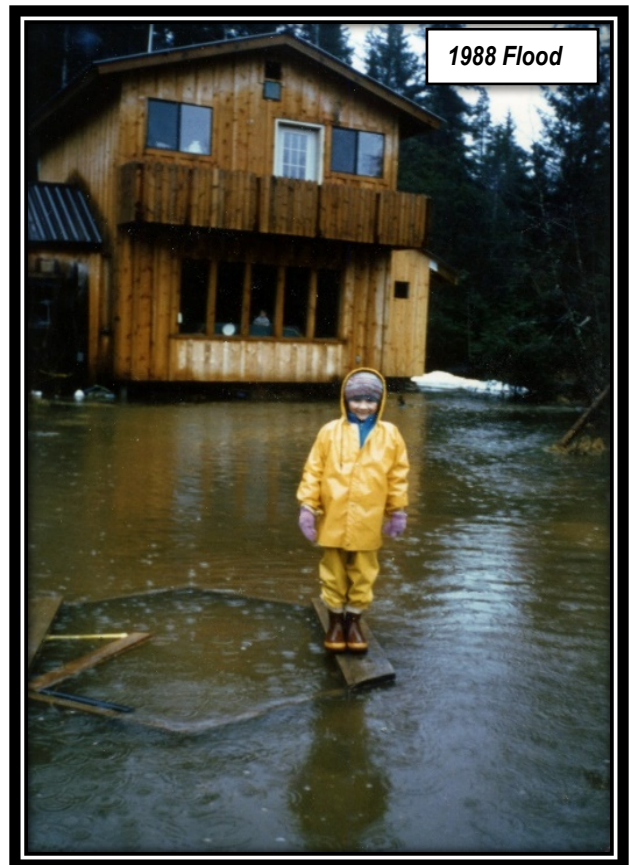
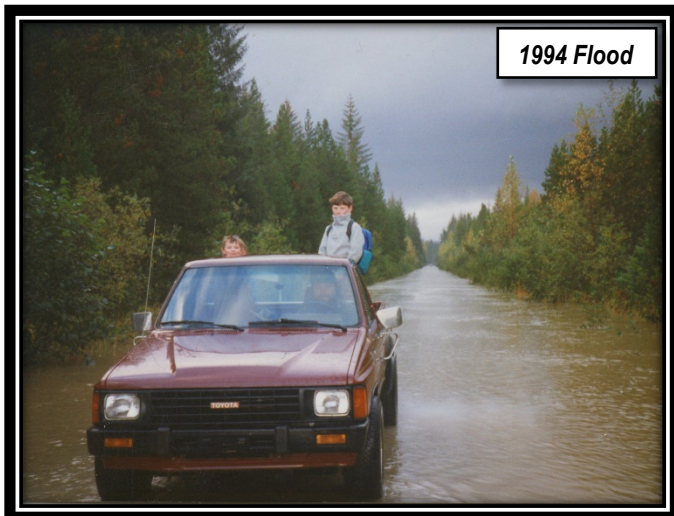
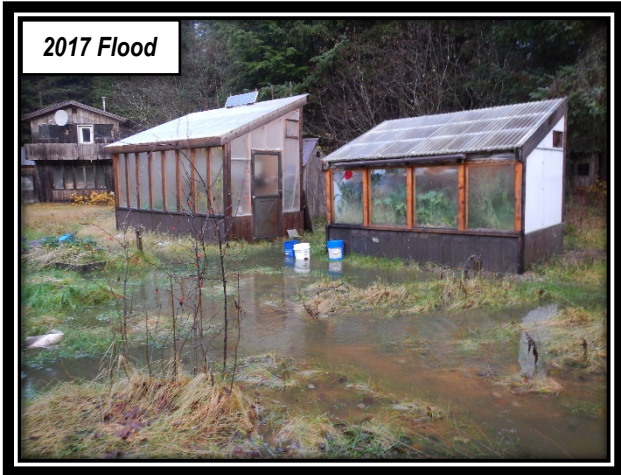
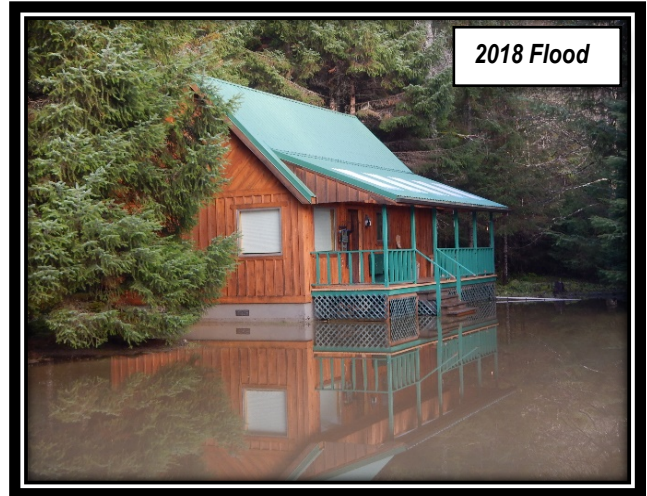
Prior to 2017, flooding occurred about every 14 years and was caused by 1) intense rainfall rates around 4.00 inches per day, 2) repeated storm events on well saturated soils, or 3) rain combined with snow melt over frozen ground. Recent floods (2017, 2018, and 2020) demonstrated that Wilson Road can be flooded with a little over two inches of rain within a 24-hour period. These floods have also been reoccurring on a nearly one-year cycle.

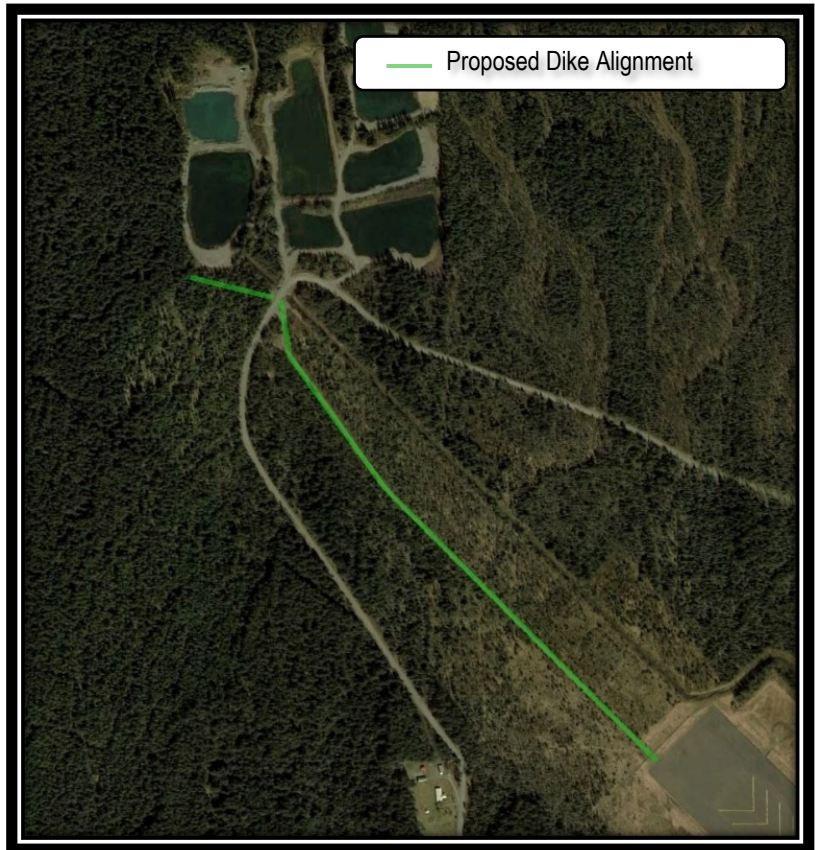
*Strategy 3 – Create a Hydraulic Dike*

By raising and lengthening runway 11/29 above the surrounding meadows, the ADOT created a nearly two-mile-long dike. Water that would attempt escaping the airport’s east-side diversion would be held in place by the raised runway. A dike raised above the height of the existing landscape connecting runway 11/29’s northern end to a natural rise southwest of the gravel pits would have the same effect. Stormwater would be confined to the diversion and longer be allowed to escape down Wilson Road. Focusing flow through the diversion would likely aid in keeping the diversion clear of sedimentation.

A barrier intended to strengthen flood defenses would prevent surface water from entering the Wilson Road corridor from upstream meadows (floodplains). Portions of the airport’s existing 0.6-mile-long northern service road in proximity to the Wilson Road/Rink Creek culvert could be raised to match the roadway’s crest elevation above the culvert. By tying in the service road in near the culvert, flow would aid in scouring out sedimentation that would threaten to the culvert’s capacity to move water.

To ensure water does not bypass the raised service road on the northwest side of Wilson Road, a new 500 to 700 ft long dike would need to be built. The material necessary to construct this dike would best be comprised of siltier material to stabilize the embankment and prevent water piping through the dike. Silty surface material generally set aside and wasted for gravel pit development could be an

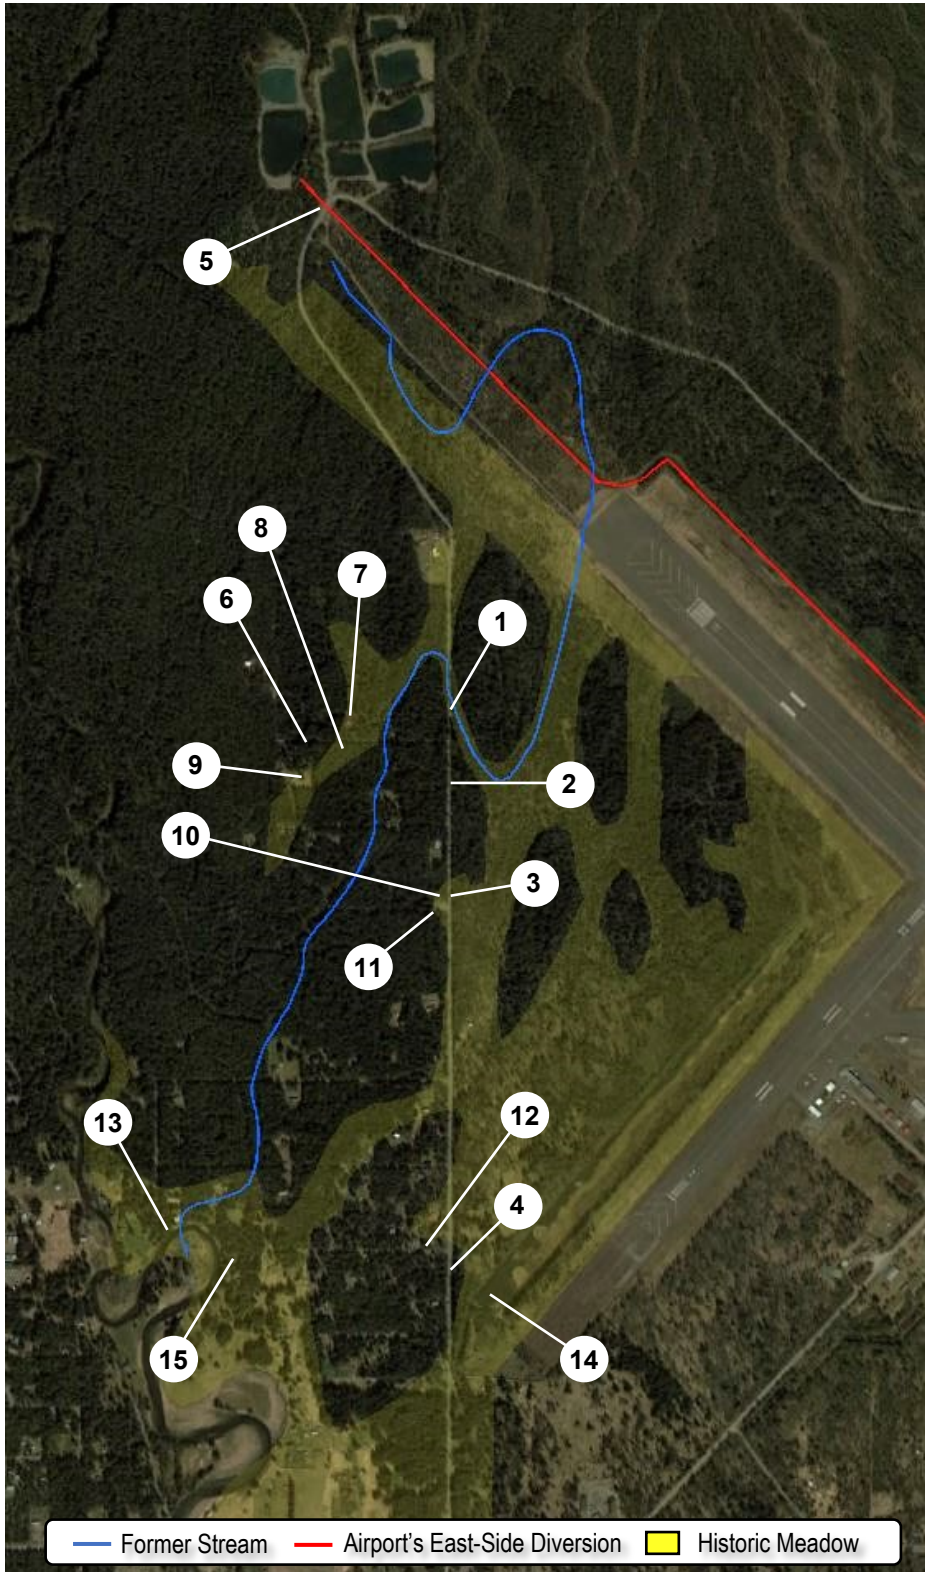
### Appendix B – December 2020 Storm Observations

Reported flood damage noted on an aerial photograph overlain with historic hydraulic features such as the former stream and meadows (floodplains) can be found in Appendix B with references to specific flood observations.

1. Wilson Road Flooding near Hemlock Road
2. Wilson Road flooding near Jensen Road
3. Wilson Road flooding near Chase Drive
4. Wilson Road damage near Dock Ponds Trail
5. Wilson Road flooding near the gravel pits
6. Flooding on Hemlock Road
7. Flooded home on Hemlock Road
8. Flooded home and vehicles on Hemlock Road
9. Flooded home on Hemlock Road
10. Flooded home on Wilson Road
11. Chase Drive flooding
12. Home flooded on Parker Drive
13. Erosion near home on River Bend Drive
14. Flooded duck ponds near Wilson Road
15. Washed out driveway on Parker Drive
